Great Earthquake

1894.

A COMPLETE REPORT OF THE EFFECTS OF THE RECENT

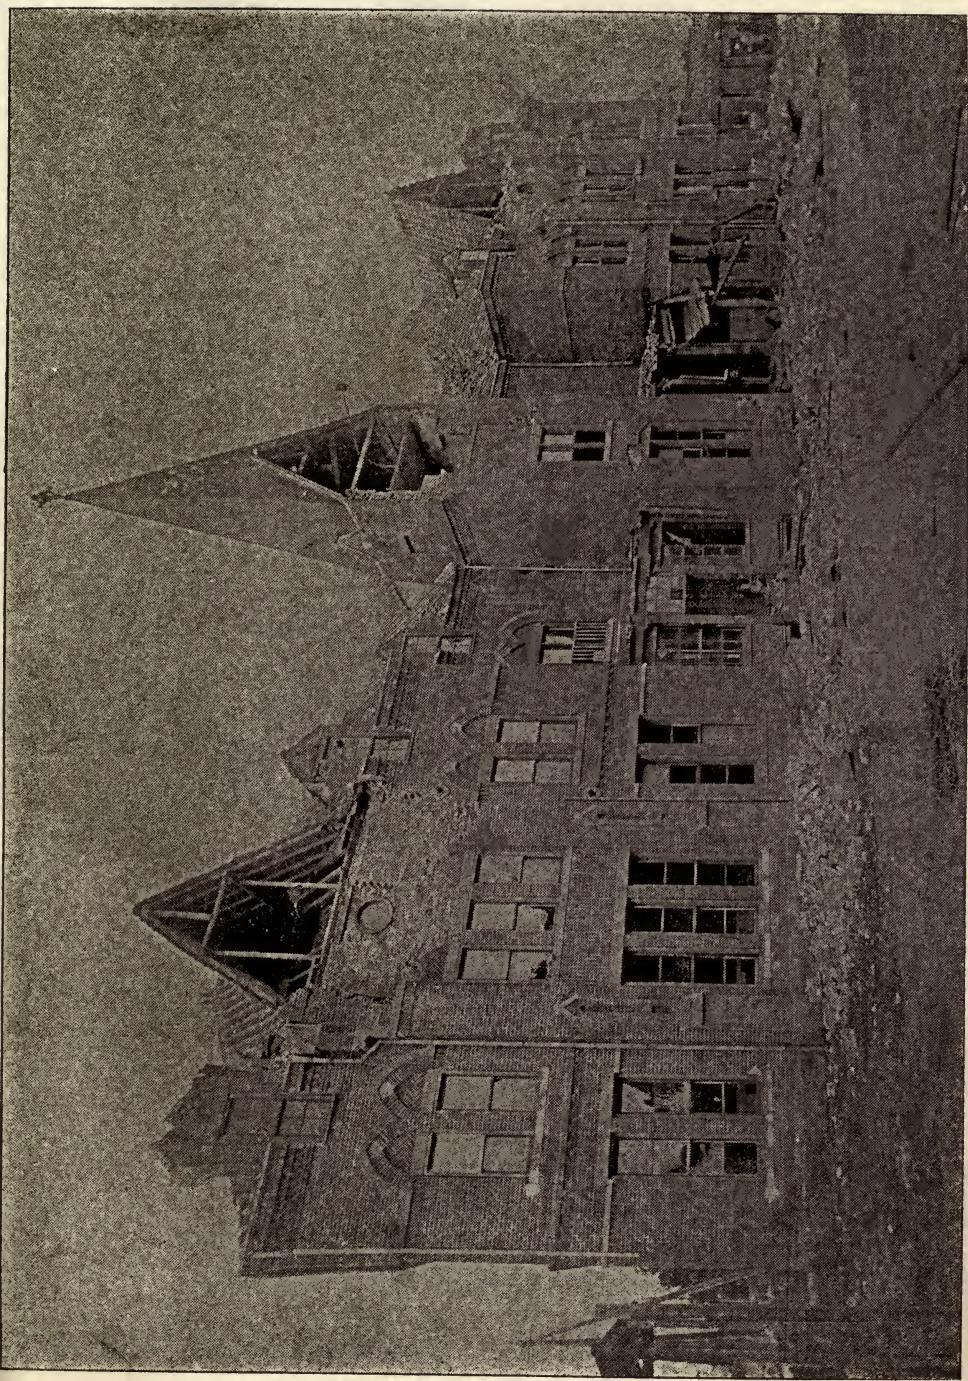
St. Paul's School at Gomti, Edmo.

The earthquake here seems to have picked out different sections of the city upon which to shew its violence. Tsukiji suffered very badly, there is hardly a house without some damage to its chimneys. St. Paul's school, belonging to the A. E. Mission, is badly wrecked. A Japanese teacher was killed in trying to leave the building. Fortunately he was about the only person in it. This seems to be the one person hurt in Tsukiji, though there were several near escapes. Bishop McKim was only saved by the thick sun hat he had on.

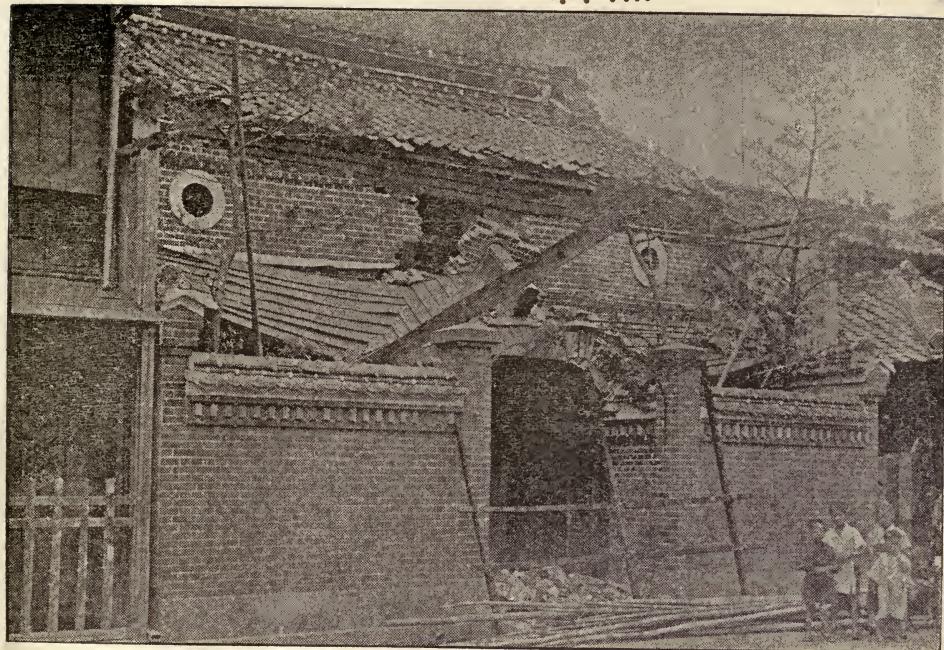
TEA-HOUSE AT TSUKIJI, TOKYO.

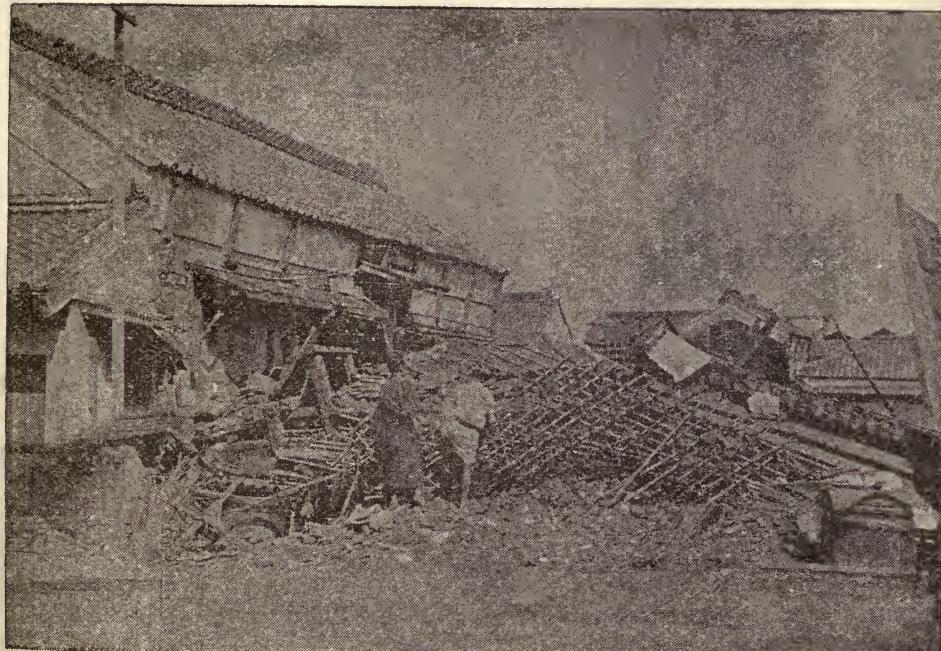
SCENE AT ZAIMOKU-CHO, KYOBASHI-KU, TOKYO.

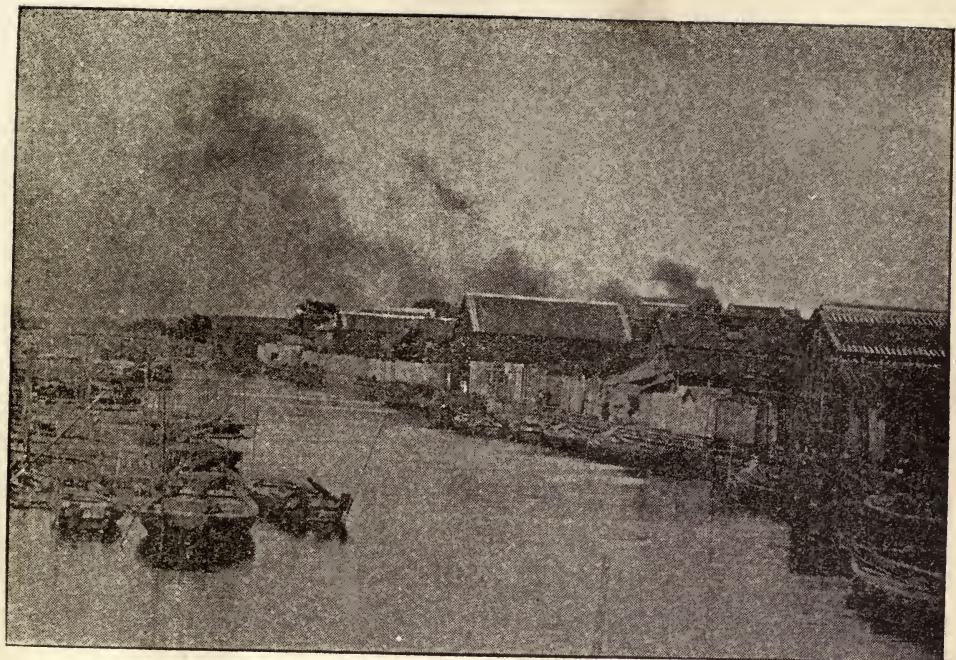
FIRE AFTER THE EARTHQUAKE AT A TOKYO KEROSENE REFINERY.

The kerosene refinery at Oshima-mura, in Minami-Katsushika-gun, was set on fire by the shock. The damage to the plant and buildings is put at 30,000 yen; and 3,000 cases of kerosene, valued at 6,000 yen, were consumed. The works were insured for 10,000 yen.

There was one fire through the earthquake. At the Kerosene Refinery, in the Komatsugawa Police limits, an oil-case fell into a hearth, and exploding, set the place on fire. The manufactory and two dwelling-houses were burnt-down.

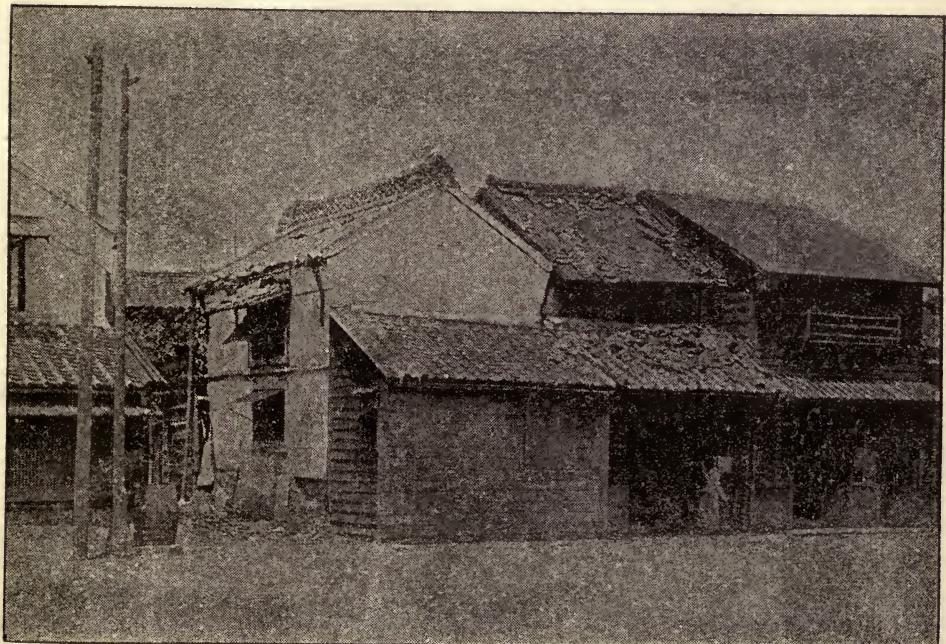
SCENE AT SAKAICHO, TSUKIJI, TOKYO.
